NTSB Advisory

December 14, 2010

NTSB ISSUES UPDATE ON INVESTIGATION INTO FATAL PIPELINE RUPTURE IN SAN BRUNO, CALIFORNIA

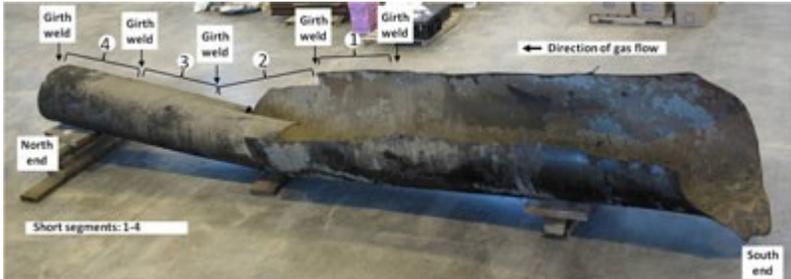
28-foot-long ruptured section of pipeline at laboratory facilities at the NTSB Training Center, Ashburn, VA ([Download full-sized version of image](#))

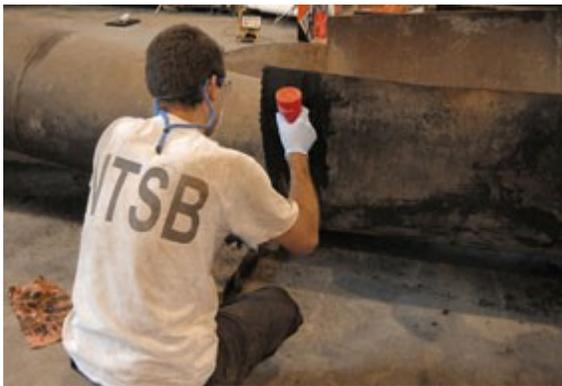
NTSB investigator examining fracture surfaces ([Download full-sized version](#))

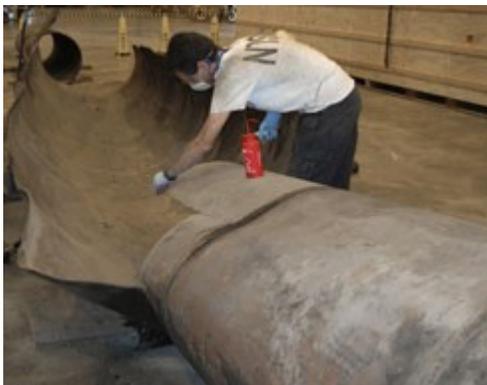
View of ruptured section of pipeline with investigator cleaning a fracture surface ([Download full-sized version](#))

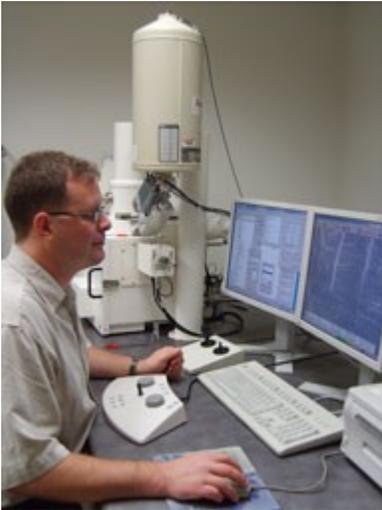
NTSB investigator using a scanning electron microscope to examine a pipeline fracture surface
([Download full-sized version](#))
