# NEVER AGAIN

## MOSS LANDING

Why and How Findings  
by the Central Coast NAML Investigation Team

**Subject:** Never Again Moss Landing (NAML), public investigation — January 16<sup>th</sup> Moss Landing BESS fire

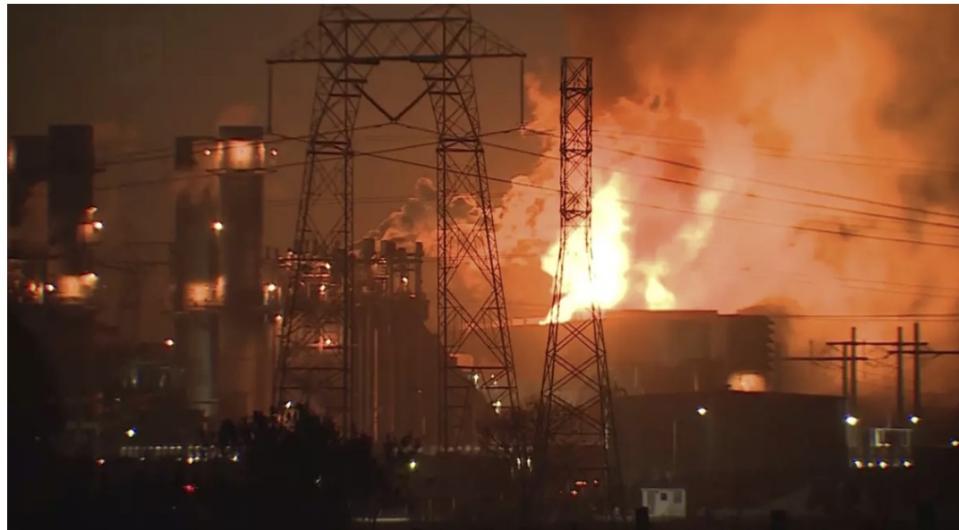
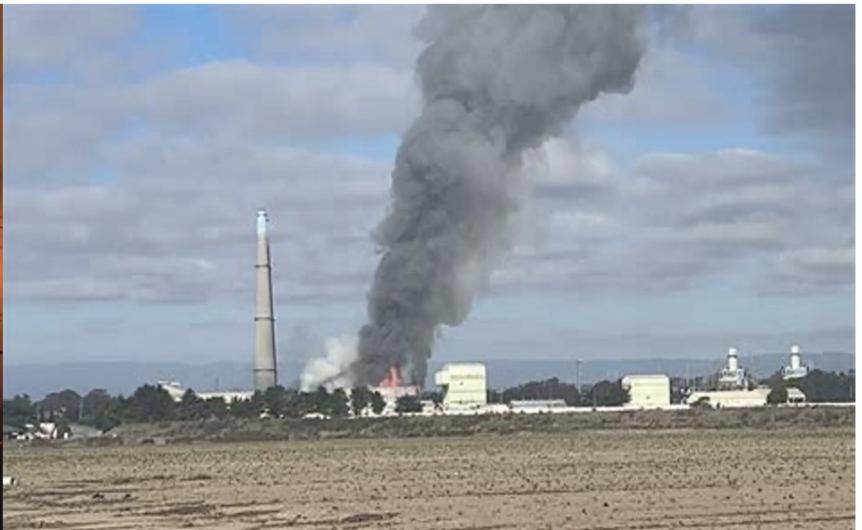
**Slide 1**

KSBW TV January 16, 2025

KION TV January 17, 2025

However, the massive flames and gushing black/gray smoke rolling out of the Phase-1 storage building prove seven facts irrefutable by the Vistra operator and by any California State regulators. The seven facts are listed below:

F-1: During 16 thru 22 January 2025, the biggest indoor lithium battery storage facility in America burned to the ground.

F-2: The **building's** suppression system **failed to suppress** because it either did not exist, was not rapidly initiated, was inadequate for the number of batteries exposed to thermal runaway heat, or it failed to operate. In fact, reporting by NBCUniversal's Jaxon Van Derbeken on April 28, 2025, revealed that in the weeks before the conflagration, Vistra modified its fire suppression system to actuate more slowly after several incidents occurred under the approved suppression system. See the report here:

F-3: The **building's** containment system **failed to contain**.

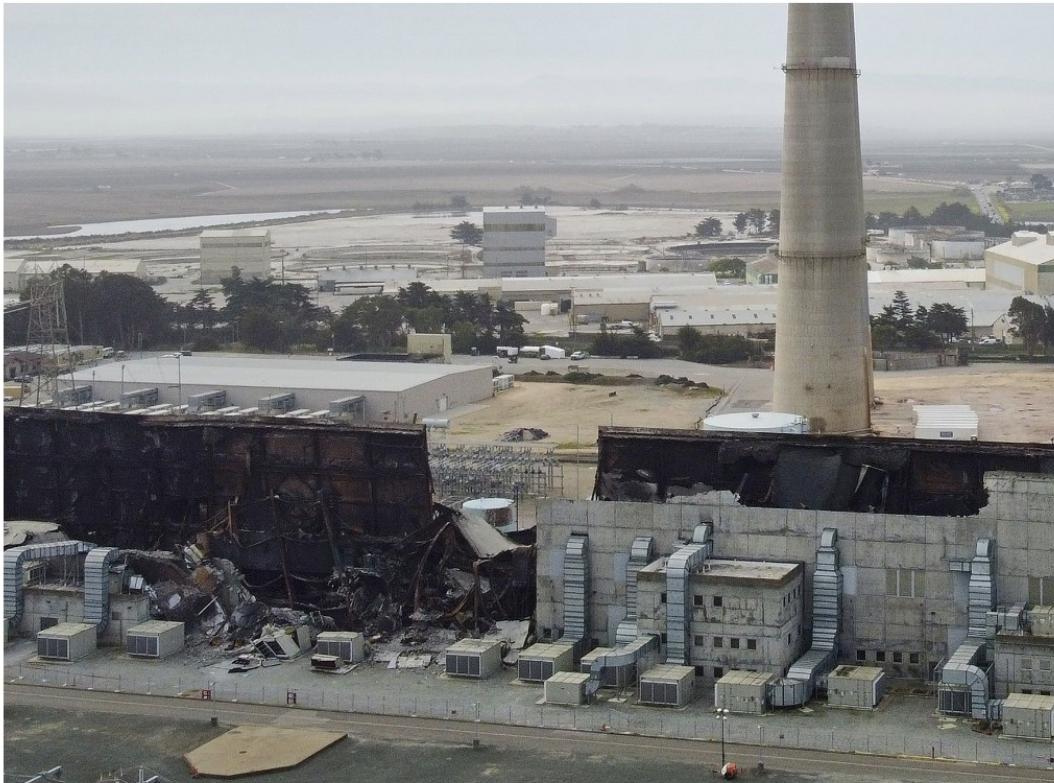
## Slide 2

### Three facts proven by burned out building and black residue

F-8: The three-story building's upper two floors collapsed onto the bottom floor because metal support beams melted or slumped from the high heat generated by the burning batteries. Burning lithium batteries self-generate oxygen as a byproduct which acts as a blowtorch, further energizing the intensity and energy of the fire. Estimates of temperatures range as high as

5,000 degrees Fahrenheit, adequate to vaporize the materials within the building, creating nanoparticles which traveled widely throughout the region on documented air currents that spread well beyond the boundaries of Monterey County.

F-10: Unstable exterior walls and tons of polluted residue will have to be removed as part of site cleaned up. A post-fire news release by Vistra notified the County and public that approximately 80% of the batteries were burned up and 20% remained to be de-linked from the grid.

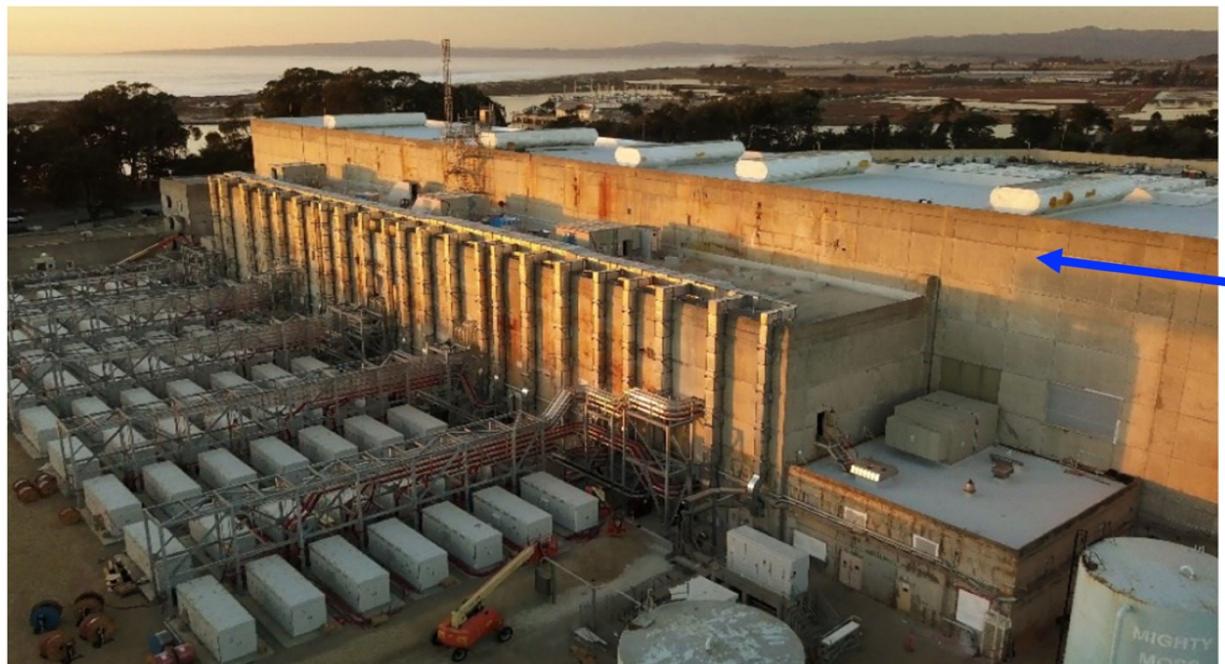
**Slide 6**

Vistra's Phase-I  
Storage Building  
before the fire

Vistra's re-purposed the turbine building on the energy storage site. It is the tallest and largest building shown on the slide. It is 800 feet long, of which 700 feet (more than two football fields) were used for battery storage based on Google Map measurements of the black burn scar.

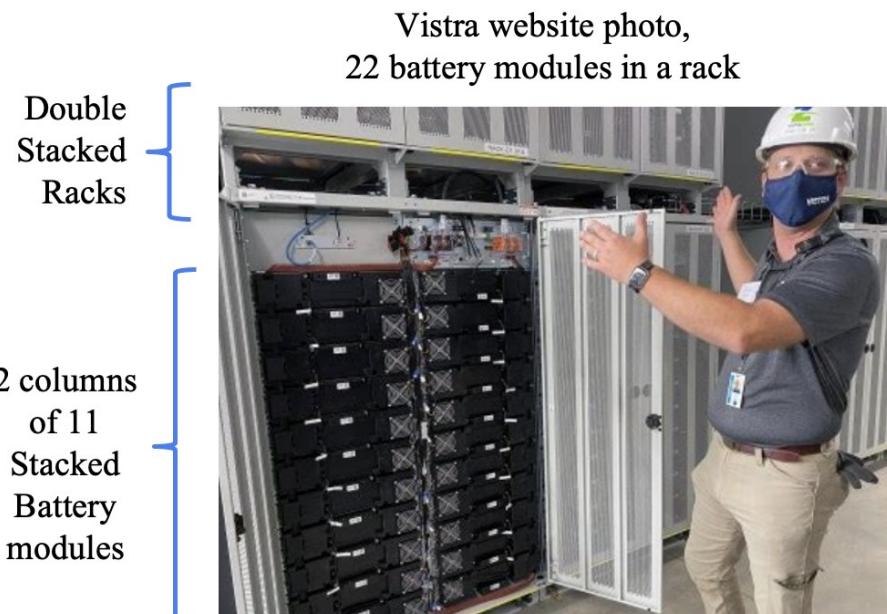
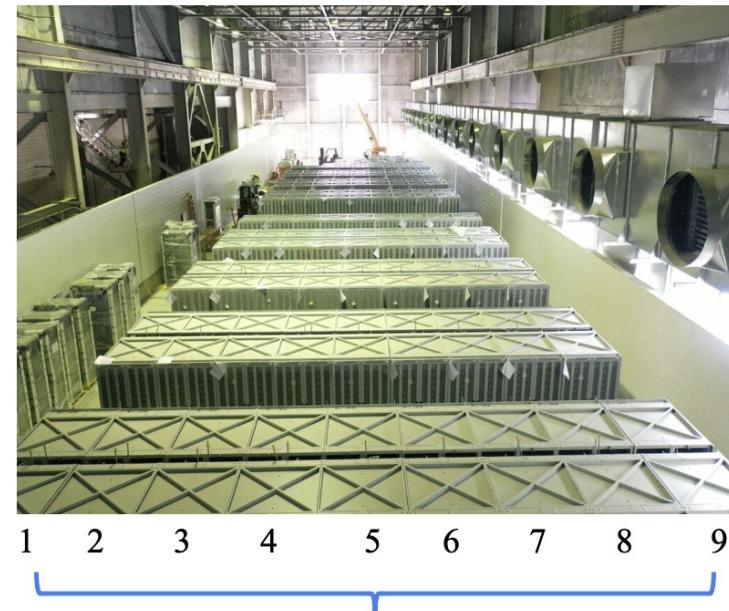
Press Release June 17<sup>th</sup> 2021 “**double-stacked feature** ...

enabled . . . full battery capacity . . .  
without the need for major construction”

LG Energy Press Release photo,  
9 racks in a single row-unit

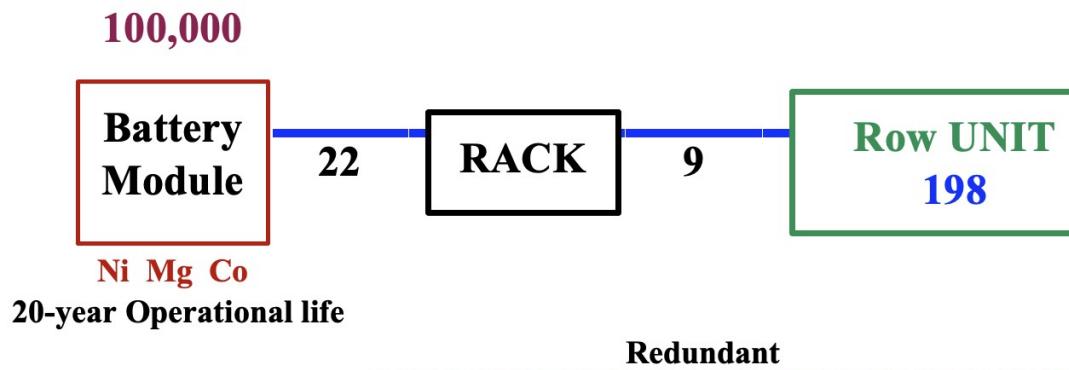
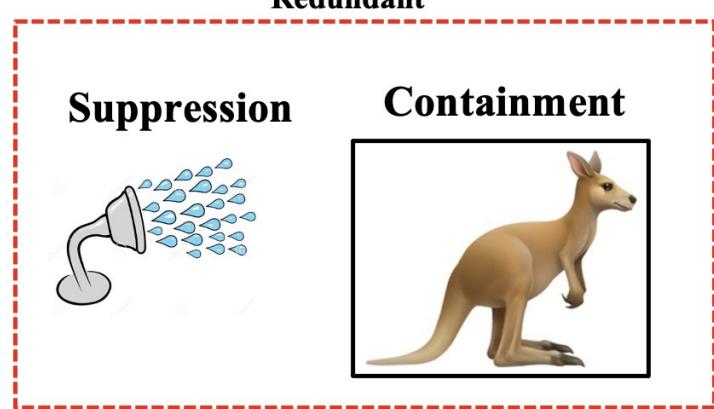
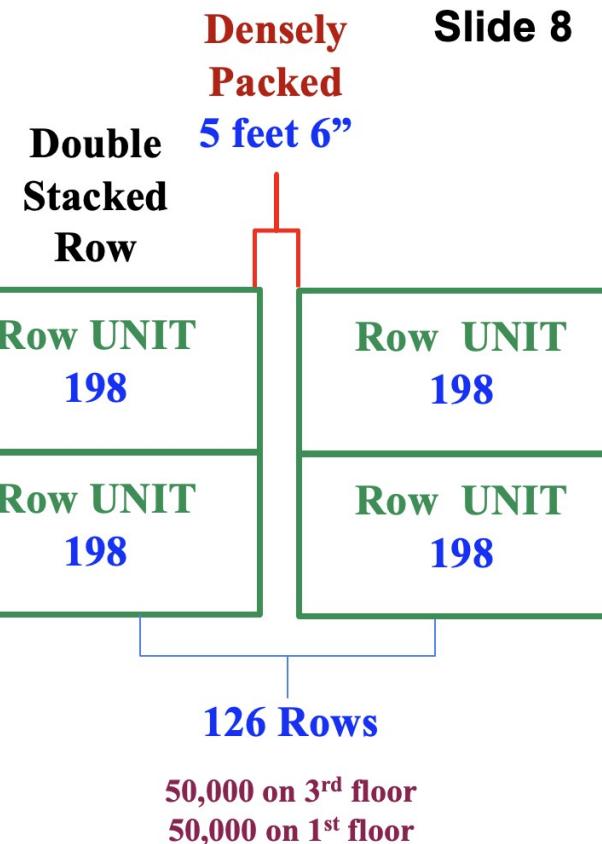
## Storage Items

Distance apart is a common containment method. So, how many rows were there and how far apart were they? The investigation team solved those questions by dividing 396 batteries within a row-unit into 50,000 batteries on the floor = **126 rows**. Then, divided 126 rows into the length of the burnt containment room (700 feet) = **5 feet 6 inches of aisle space between rows**. Meanwhile, stacked items had zero distancing.

Initial Study & County Planning documents  
& January 21, 2025 BoS emergency meeting

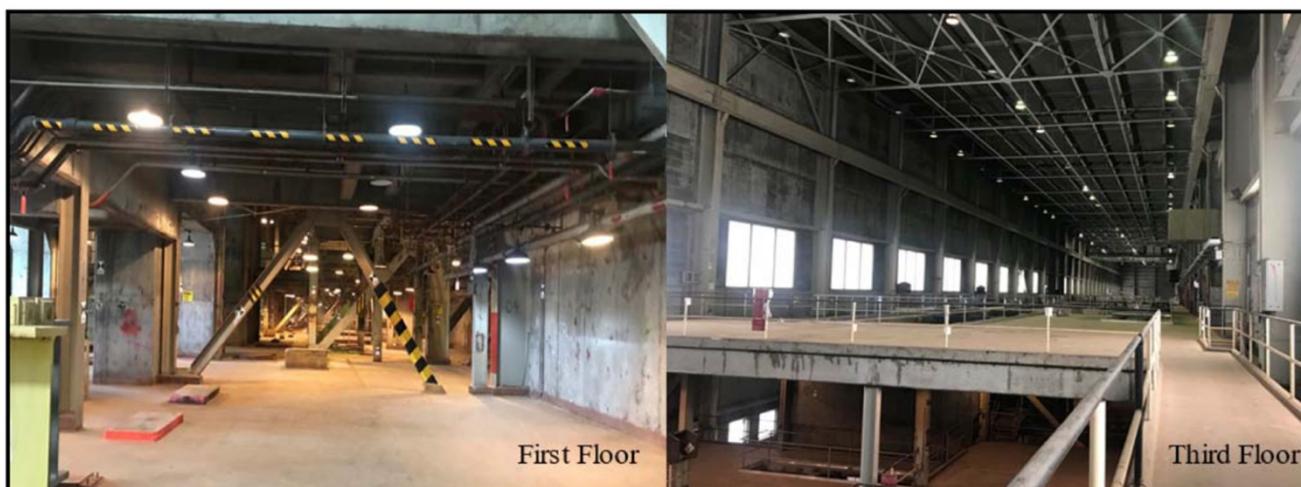
### Refurbished Interior, Phase-I Storage Building

The Vistra photo shows the third floor's expansive storage area prior to battery installation, with **no intervening walls**, where at least 50,000 batteries were planned to be stored, along the full length of the floor. Thus, 50,000 batteries were eventually positioned **PRONE, to be completely burned up if uncontained thermal runaway couldn't be stopped by the building's suppression system**. However, if one or more, fireproof and firestop intervening walls had been constructed, the probability of all batteries on the floor catching on fire — **would have been reduced**. Plus, the large gap in the floor, if not closed, would allow toxic gasses, smoke, heat, and water to flow into or from the 2<sup>nd</sup> floor area and thus fail to achieve Underwriters Laboratories UL 1479 firestop safety standards to stop such spreading through a fire-rated barrier for a specified period of time.

2019 PLN180394 Permit Initial Study & Exhibit E Page 4

Third Floor with highest ceiling & showing full storage width & length, & no intervening walls

Third Floor **with gap** opening to 2<sup>nd</sup> floor. Gap prevents achieving Fire Stop safety standard

Additionally, the left-side photo shows no intervening walls. Thus, the floor was a huge single room. Plus, if the floor gap shown on Slide 9 and Slide 10 was not sealed shut, firestopped, and fireproofed then the 3<sup>rd</sup> and 2<sup>nd</sup> floors were one big room, PRONE to completely burn up all the batteries on the floor, if uncontained thermal runaway couldn't be stopped by the building's suppression system.

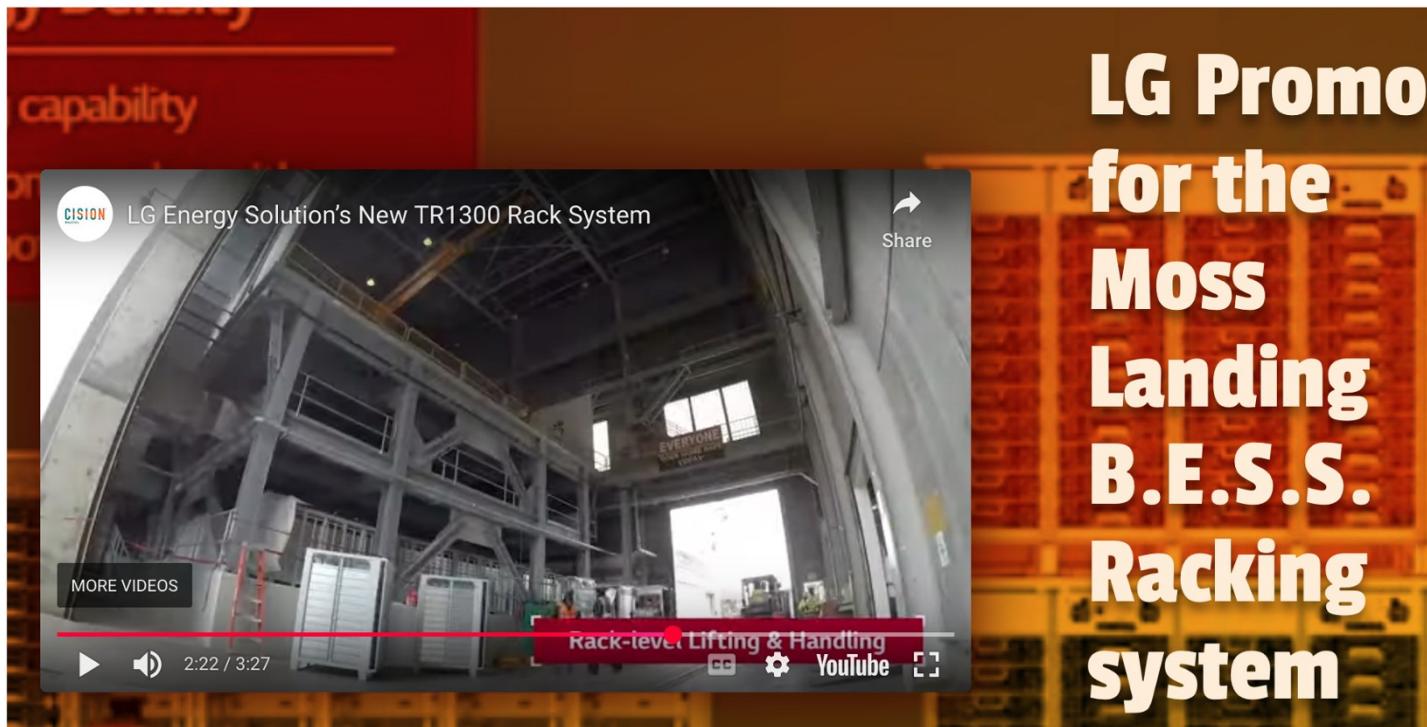
## Slide 10

The 3-Story gap may have turned the building into **ONE big Room**

LG Energy's promotional Moss Landing video

However, Vistra's Initial Study and permitting documents claimed the 1<sup>st</sup> floor storage area had fireproofing and a separate entrance door. But that documentation **did not reveal** the degree of firestop used to ensure the lower floor would not be impacted by toxic gases, smoke, heat, and water. On the contrary, as Vistra reported, the September 4, 2021 smoke and suppression (S&S) incident **did leak water** into the “lower” storage room; **meaning the 1<sup>st</sup> floor**.

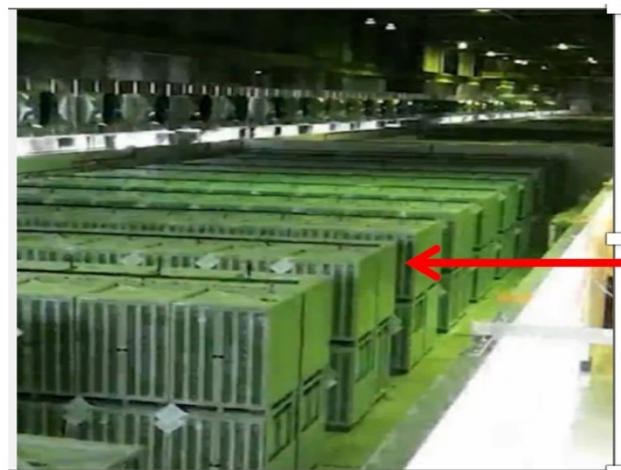
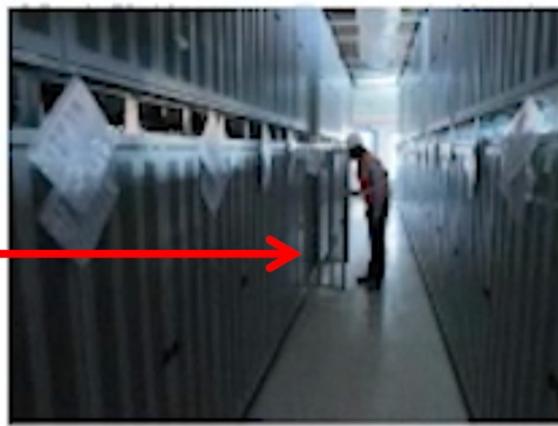
The left-side photograph on Slide 11 comes from the PUC's incident report about Vistra's Phase-1 September 4, 2021 loss of nearly 7,000 batteries because smoke sensors triggered water suppression spraying when the smoke wasn't from any of the batteries. Unfortunately, leaks in the suppression water lines started shorting out **properly operating batteries** on the 3<sup>rd</sup> floor. Then the smoke sensors properly triggered more suppression water. Vistra added to the PUC's report explaining that the suppression water flowed down to the "lower floor" and shorted batteries there. That leakage proved that the 3<sup>rd</sup> floor **was not firestop sealed**, where the incident started, to prevent water, gas, and heat from reaching down or up through the floor.

Phase-I Storage building's double-stacked 5ft 6 inch unit-row aisle spacing

PUC Incident report page  
F-19 - Sept 4, 2021;  
Vistra sprayed water

Vistra Community  
Meeting  
Mar & April 2024

Even before reading the incident report, the height of the ceiling and the line of windows stretching to the far end of the room prove the photo is of the Phase-1 3<sup>rd</sup> floor. So, the slide shows the actual installed layout of the double-stacked row-units on the 3<sup>rd</sup> floor, as well as the narrowness of the separation aisles which were previously calculated to be 5 feet 6 inches wide. Supporting that calculation is the right-side photo that Vistra representatives showed to the public during Vistra's community meetings in March and April 2024 down in Moro Bay where they were working to get public support to build a BESS located on the edge of that coastal town. The public raised questions about the incidents at Vistra's Moss Landing Phase-1 BESS and Vistra presented them the right-side photograph showing a technician in an aisle between two row-units. Notice how close the employee's head is to the opened rack, as well as how close his back is to the opposite row-unit. It is obvious from Vistra's own photograph that the employee could easily touch each row-unit with outstretched arms, and that the physical spacing might be even narrower than the calculated 5 feet 6 inches.

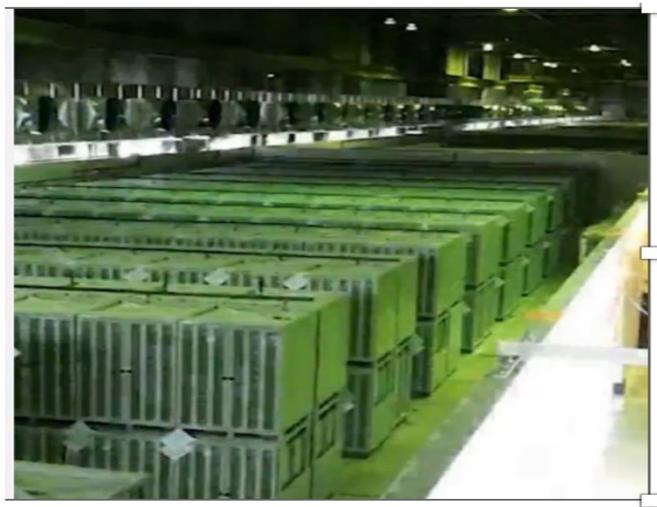
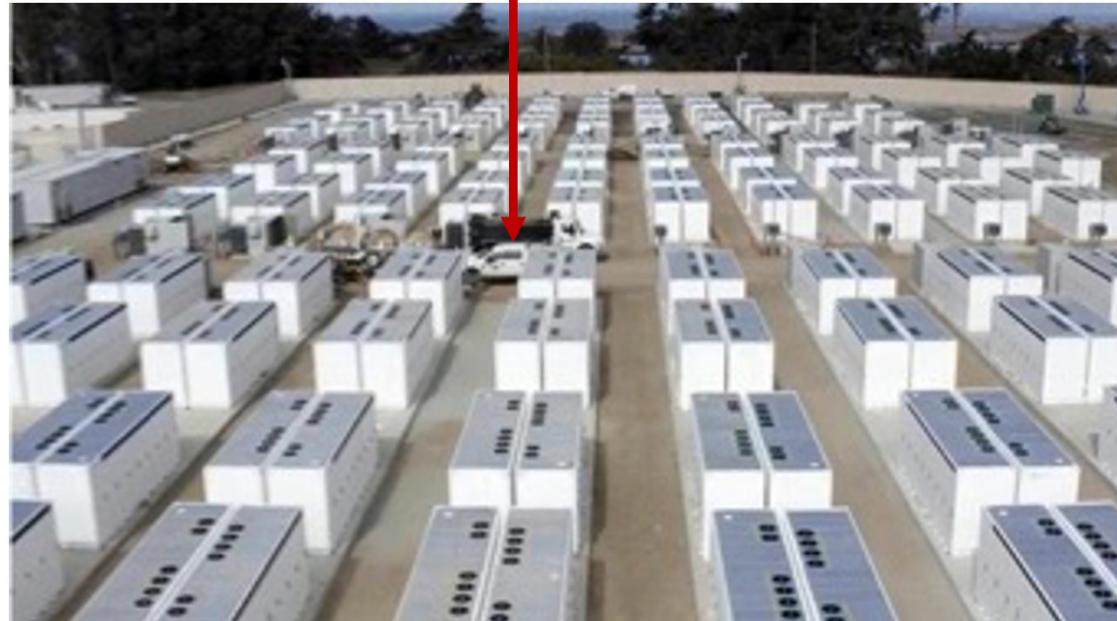
Indoor versus Outdoor Spacing Between Rows  
5ft 6 inches vs 8 feet 2 inches

Why is the Vistra's indoor row-unit aisle spacing narrower than PG&E's outdoor aisle spacing?

PUC Smoke & Suppression  
Incident report page F-19  
Sept 4, 2021

Pickup reveals aisle width

April 2021 drone image provided by Pacific Gas and Electric Company (PG&E) shows Tesla Megapack system in Moss Landing, Ca., that is now operational. (PG&E via AP).

The right-side photo in Slide 12 shows PG&E's outdoor storage yard as of April 2021, with a pickup truck parked beside a row-unit aisle. Visual comparison of that outdoor width versus the indoor aisle width in the left-side photo — appeared to the investigators

That comparison begs a question. **Why would a storage operator position large numbers of batteries closer indoors than an operator would outside?** Our investigation team felt such spacing went against 250 years of American history for storing military munitions, as well as against dynamite production safety procedures applied by California Powder Works, the largest dynamite producer west of the Rocky Mountains from 1870 to 1920 in Santa Cruz, California. Thus, from a risk perspective, narrower storage **increased Phase-1 storage to a high-risk condition.**

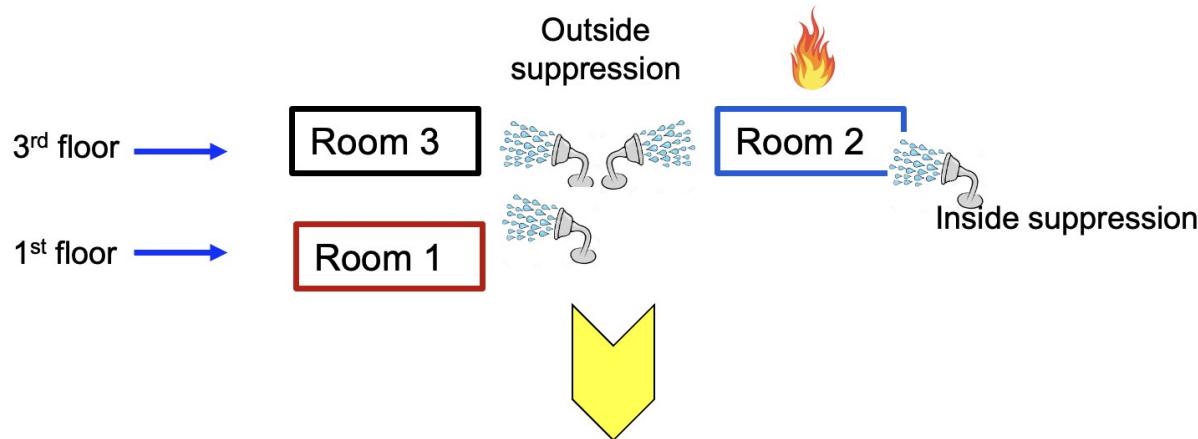
Every time you add another physical item – probability of failure **rises**

One way to **reduce storage risk** is to separate batteries into fireproof, firestop rooms. For example, 3 rooms each holding thousands of batteries. Then, in case of thermal runaway only 1/3<sup>rd</sup> of the battery inventory is lost.
